Technical Report N-138
November 1982

PRELIMINARY GUIDELINES FOR SAFE AND EFFECTIVE USE
OF HOT, HIGH-PRESSURE WASHERS
FOR MAINTENANCE CLEANING OF ARMY VEHICLES

by
S. R. Struss
J. E. Matherly
E. A. Meronyk
R. J. Scholze

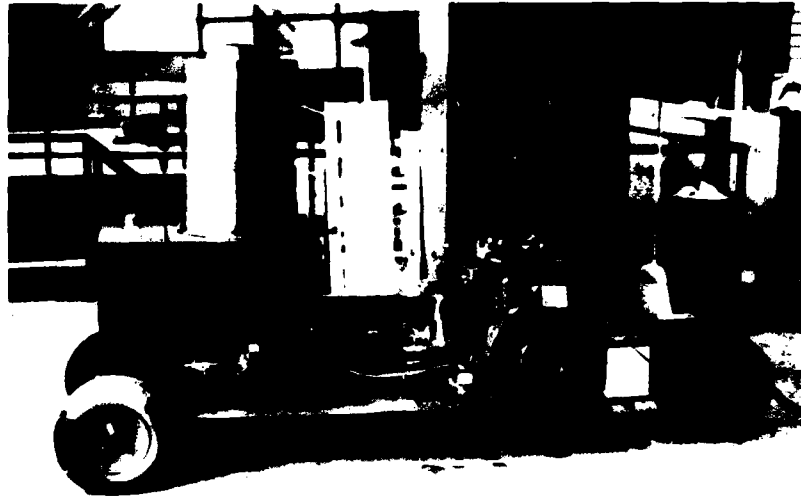
Figure 2. Hot, high-pressure washer used in lab study.

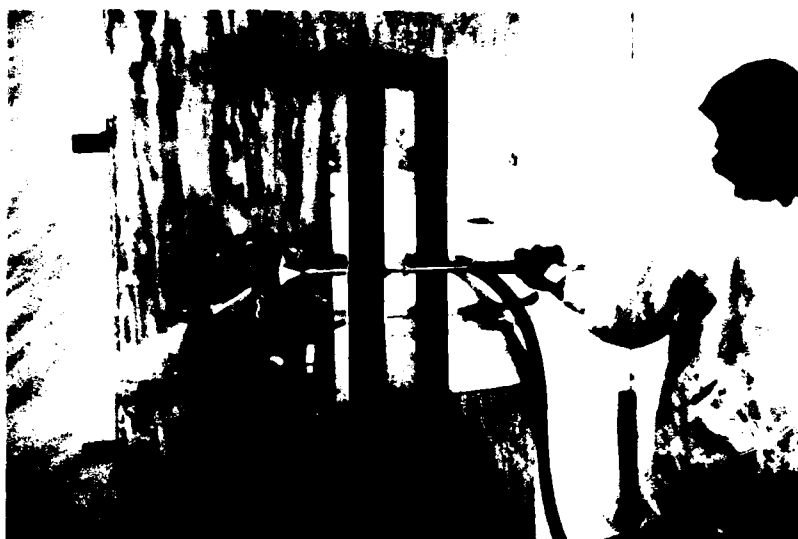
Figure 3. Final drive seal being tested in lab study.

Final drive input seals were tested on a final drive gearbox which was mounted on the test stand in a position similar to that found on an armored personnel carrier (APC) (Figure 3). Seal failure was defined as having occurred when water entered the gearbox. Although this water might not cause early failure of

the final drive, it is undesirable because it could lead to corrosion of internal parts and breakdown of the lubricant. To determine when a potentially damaging amount of water entered, two wires connected to an ohm-meter were installed in the lower part of the gearbox. An accumulation of water completed the circuit and produced a reading on the ohm-meter.

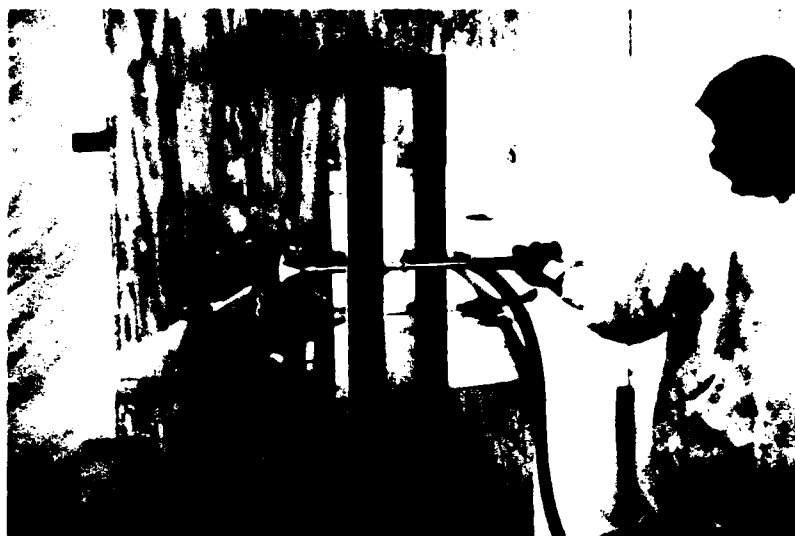
Figure 3. Final drive seal being tested in lab study.

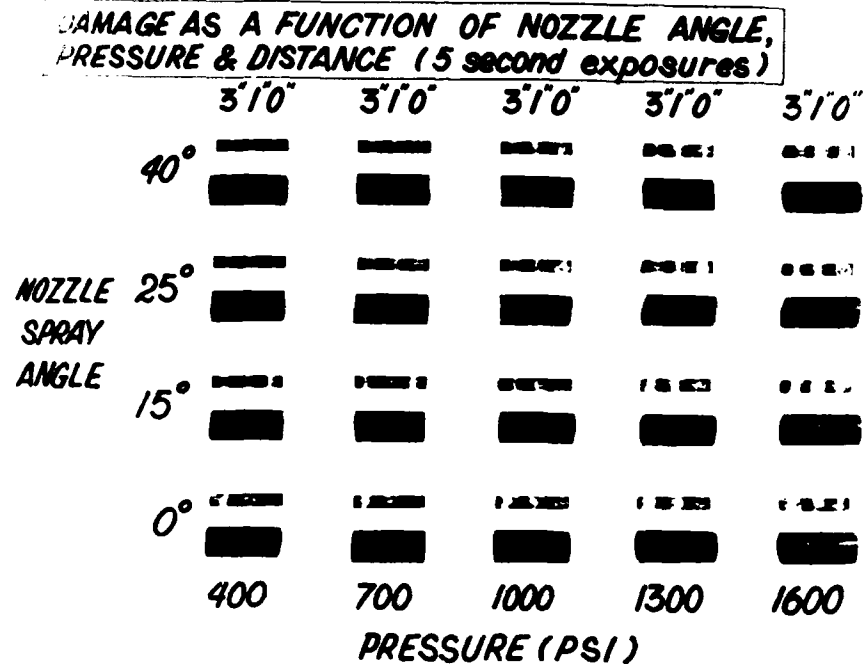
Figure 4. Damage as a function of nozzle angle, pressure, and distance.

V-beltting was studied along with radiator hose in the display board tests. Figures 4 through 8 show samples of V-belt mounted directly above radiator hose samples which have been subjected to identical sprays. These tests indicated that, in general, V-belts are

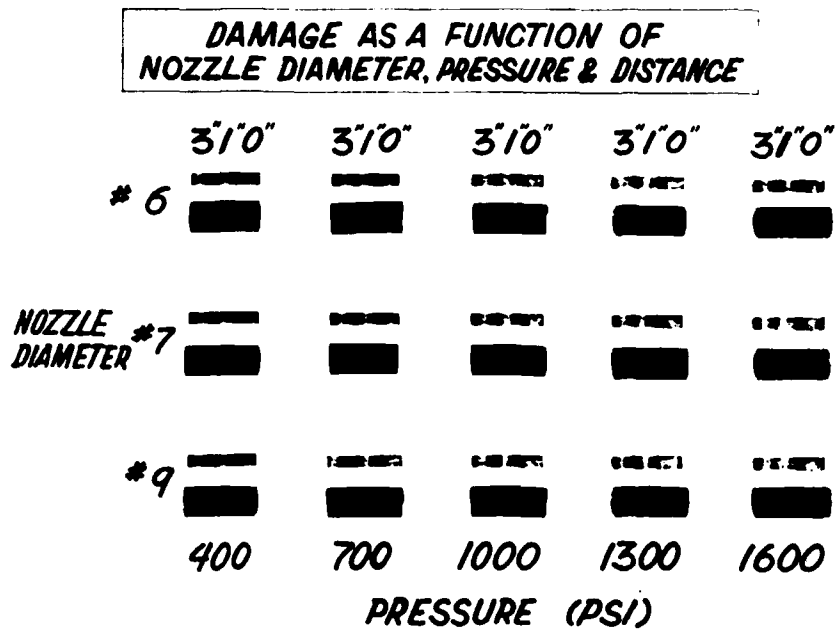
Figure 5. Damage as a function of nozzle diameter, pressure, and distance.

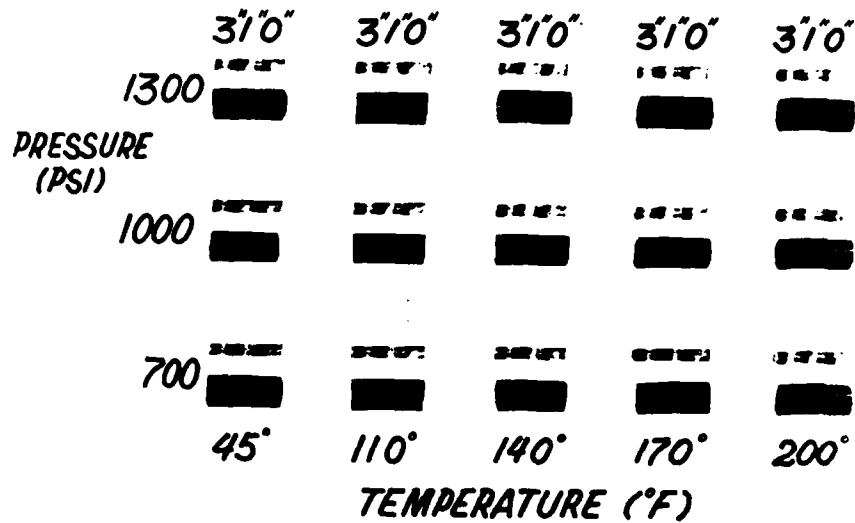
Figure 6. Damage as a function of temperature, pressure, and distance.

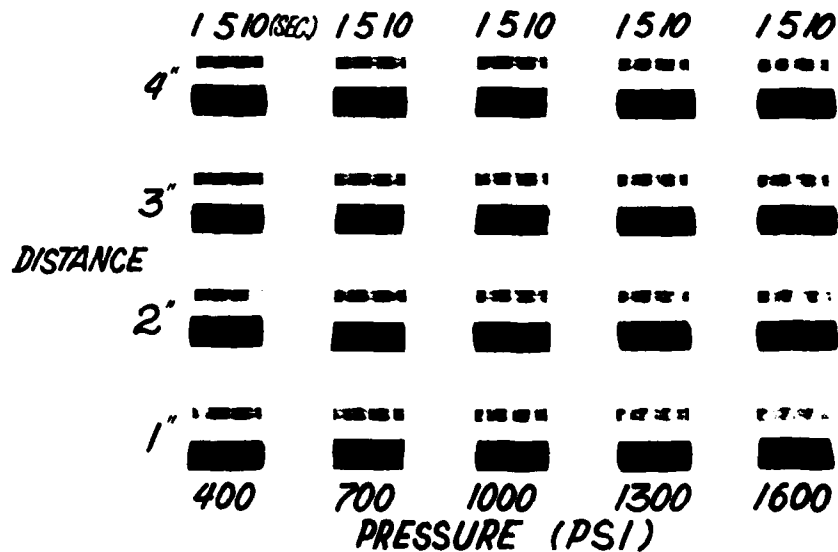
Figure 7. Damage as a function of distance, pressure, and time.

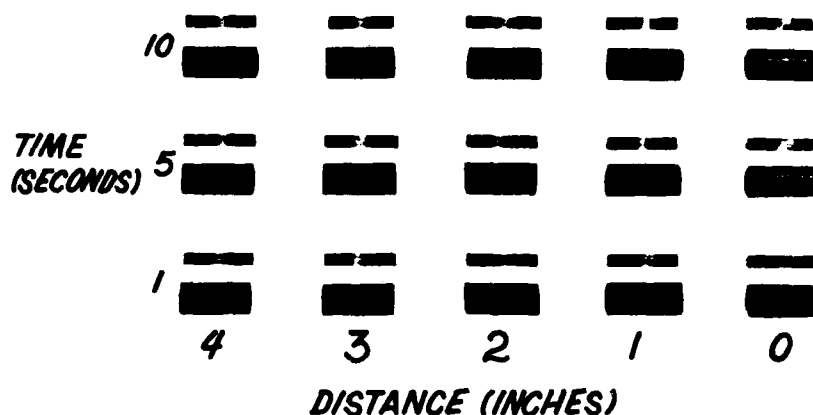
*** 800 PSI, 130°F, * 9-25° NOZZLE**

Figure 8. Potential damage as a function of time and distance at recommended settings.

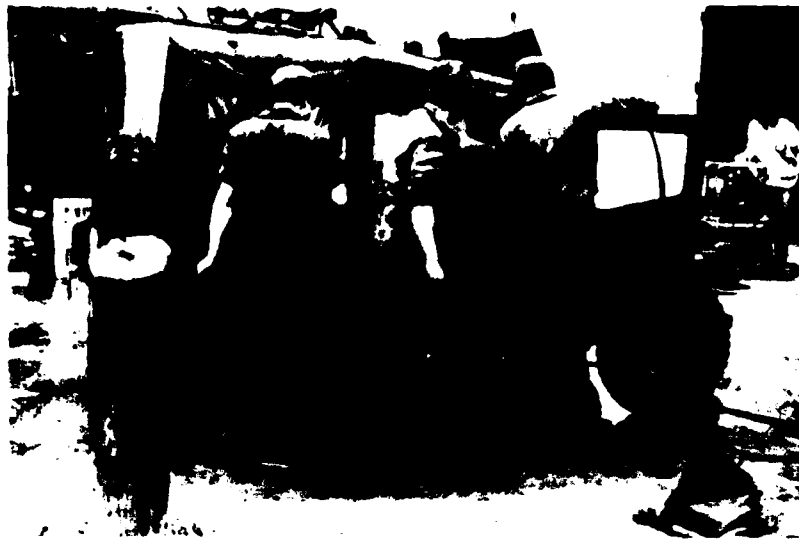
Figure 11. Jeep being cleaned during field study (hot, high-pressure washer in background).

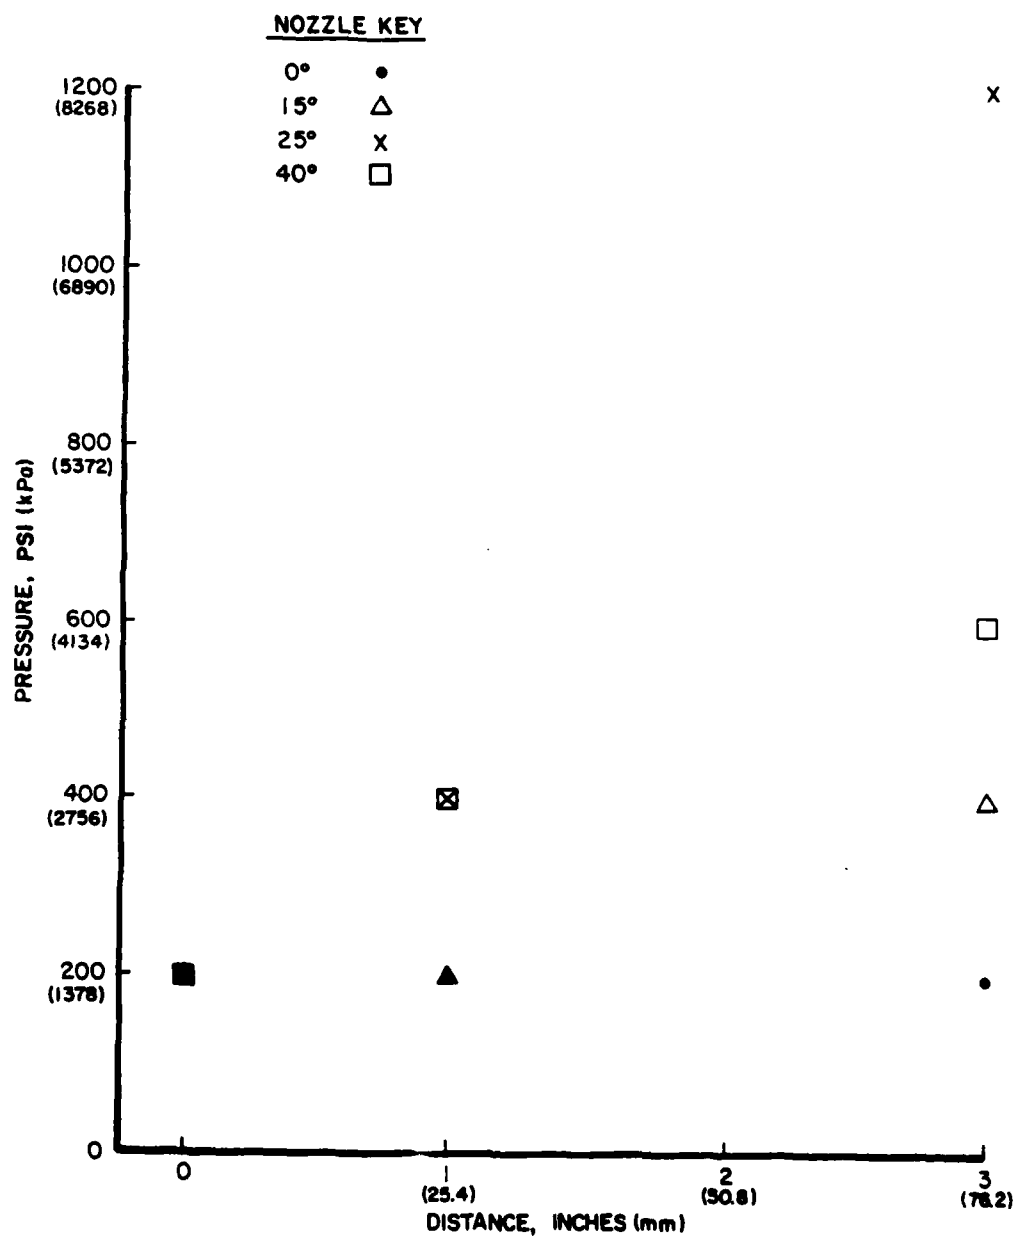
Figure 12. Final drive seal failures as a function of pressure, distance, and nozzle spray angle (No. 9 nozzles, 45°F [7.2°C] water, 10-second exposure times).

Figure 12 shows the results obtained when final drive input seals were tested with different spray angles. The results of one pressure and temperature test are shown in Figure 13. Figure 12 indicates very strong correlations between spray angle and seal failure, and between distance and seal failure. The more dispersed the spray (the wider the spray angle), the less likely failure will occur at any given pressure. However, this effect is reduced as the nozzle is moved closer to the seal and the spray becomes more concentrated. The one inconsistency in the data is the 3-in. (76-mm) test using the 25-degree nozzle. One would expect seal failure at a lower pressure than with the 40-degree nozzle, not at a higher pressure as indicated. This is explained by the fact that the 25-degree nozzle, which was manufactured by a different company than the other nozzles, had a slightly wider spray pattern, as measured across the minor axis. Since this difference is not believed significant, studying each manufacturer's nozzles is not necessary. As long as the nozzles produce a fan-type spray pattern (considerably longer on the major axis than on the minor axis), the results should be similar to those found here.

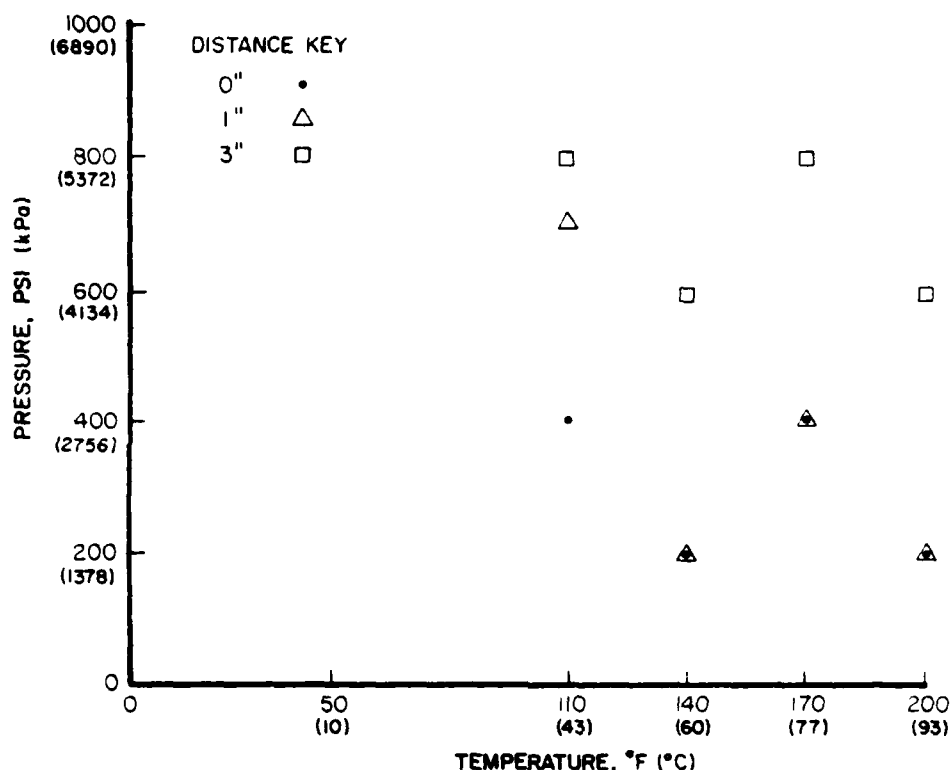
Figure 13. Final drive seal failures as a function of pressure, temperature, and distance (25-degree, No. 9 nozzle; 10-second exposure times).

Figure 13 illustrates the effect of temperature on seal failure. The relationship appears to be very weak and is probably insignificant. This figure also reillustrates the influence distance has on seal failure.

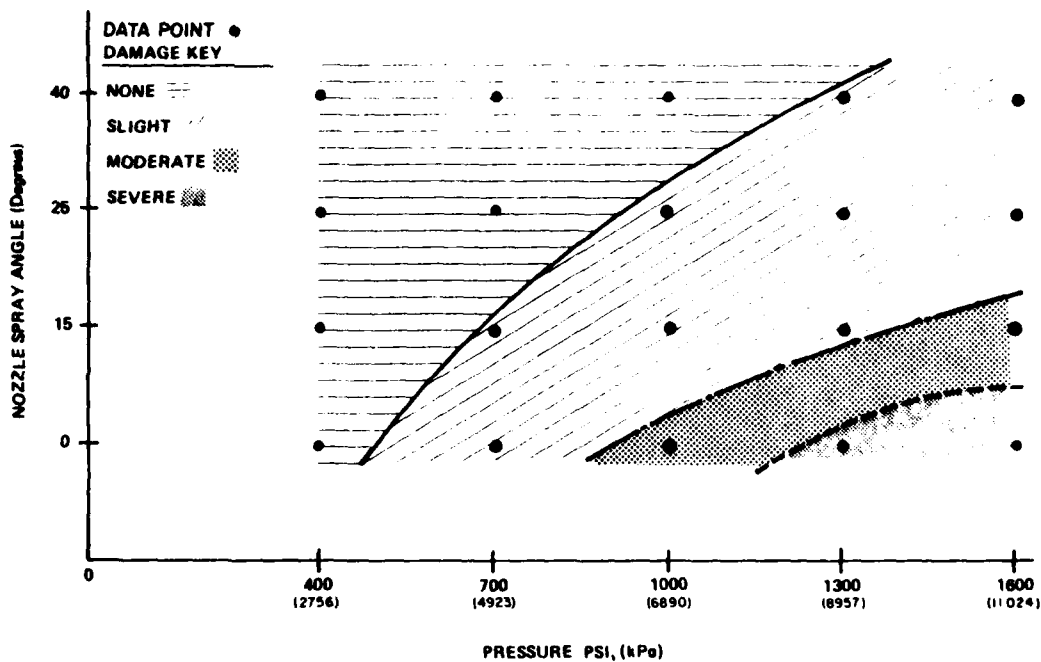
Figure 14. Damage to radiator hose as a function of nozzle spray angle and pressure (45°F [7°C] water, 3-in. [76.2-mm] distance, No. 9 nozzle, 5-second exposures).

Figure 14 shows the influence nozzle spray angle has on damage. In general, the wider the angle, the less damage to the hose at any given pressure, distance, flow rate, temperature, and exposure time. If minimizing damage were the only consideration, it would follow that the 40-degree nozzle is the best choice. However, wider sprays do not clean as well as narrower ones. During the lab study, it was determined that the 25-degree nozzle represents a good compromise between maximum cleaning effectiveness and minimum potential for damage.

In each of Figures 14 through 17, pressure is a variable. This means that to find the best settings for nozzle angle, flow rate, and temperature, the most appropriate pressure setting had to be determined first. This was done with the field tests discussed on pp 21 and 22.

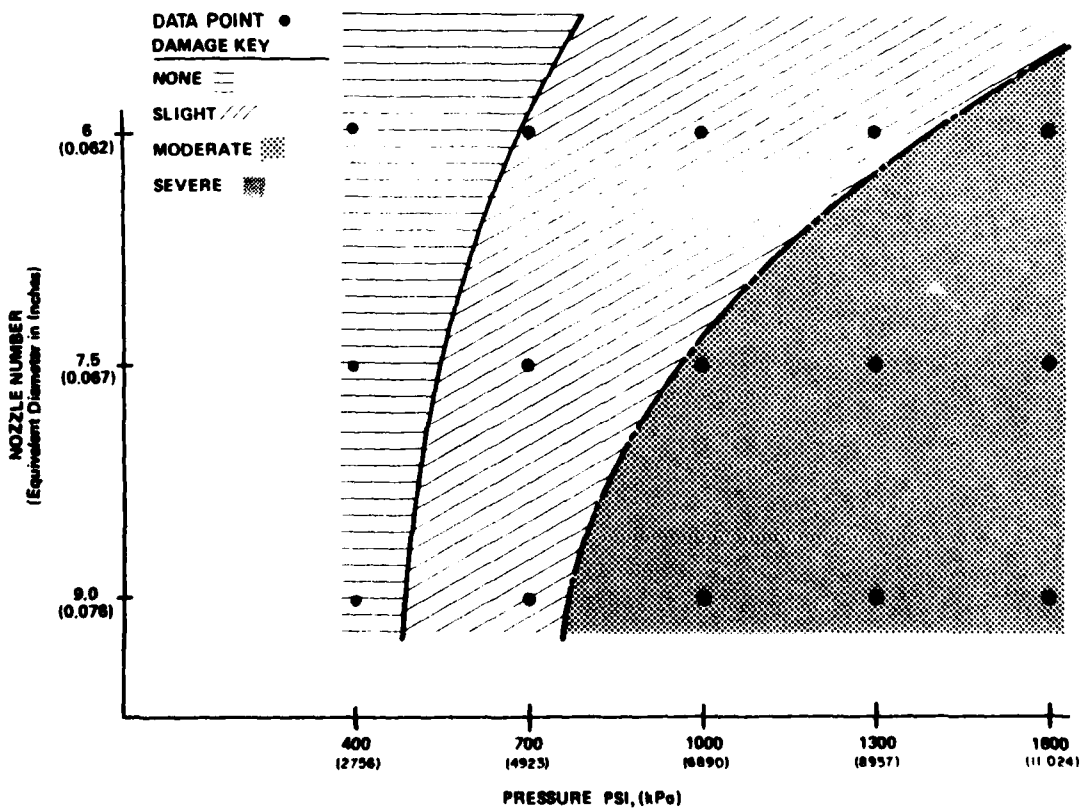
Figure 15. Damage to radiator hose as a function of nozzle size and pressure (45°F [7°C] water, 1-in. [25.4-mm] distance, 25-degree nozzle angle, 5-second exposures).

Figure 15 illustrates the effect nozzle size, or flow rate, had on hose damage. Although some effect can be seen, it is not marked, as the vertical nature of the damage zones indicates. Because of this, the choice of flow rate can be based primarily on other factors, such as cleaning effectiveness, without significantly increasing the potential for damage.

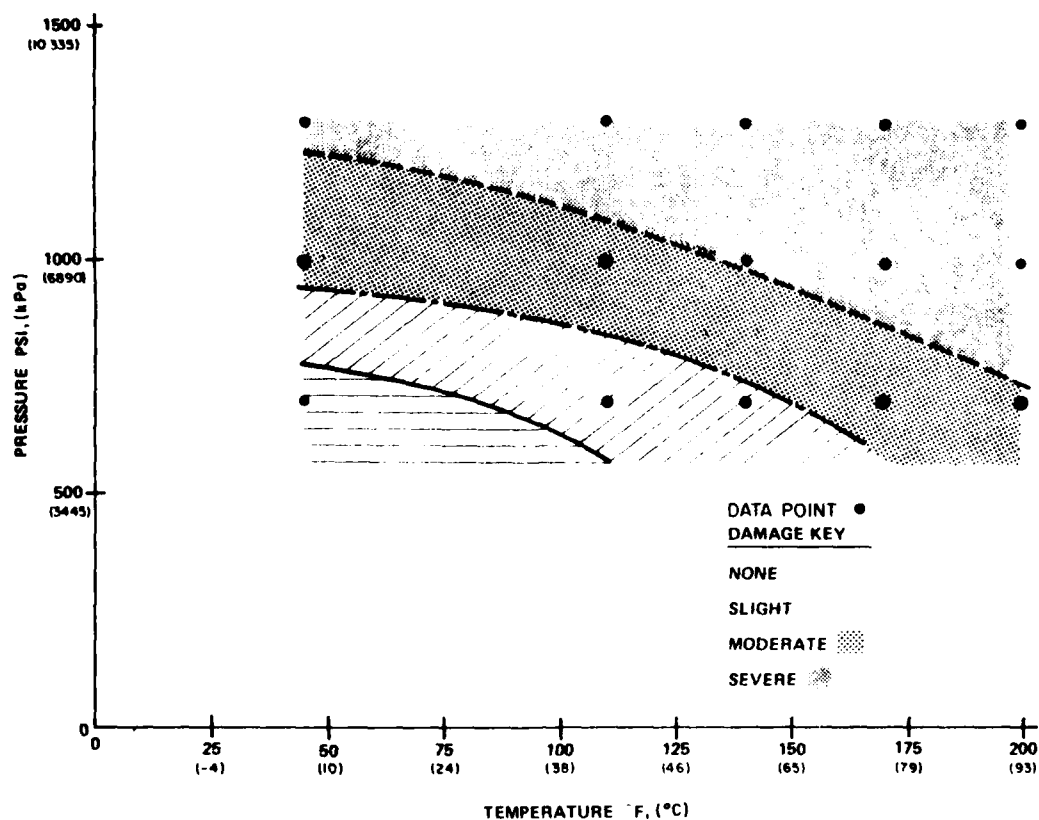
Figure 16. Damage to radiator hose as a function of pressure and temperature (0-in. distance; 25-degree, No. 9 nozzle; 5-second exposures).

Figure 16 shows the effect of water temperature on hose damage. As with flow rate, the influence is not strong. Based on these data alone, almost any temperature appears safe in the lower pressure ranges, and most temperatures above ambient appear slightly harmful at elevated pressures. It would be difficult to choose the best temperature without first considering cleaning effectiveness and safety. These are discussed on pp 21 and 22.

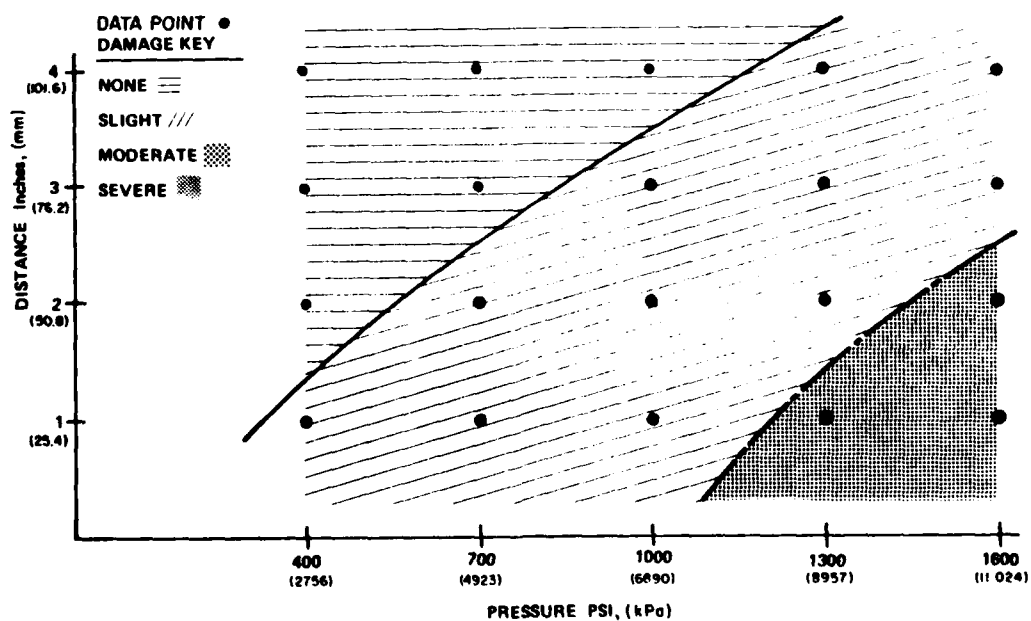
Figure 17. Damage to radiator hose as a function of distance and pressure (130°F [54°C]; 25-degree, No. 9 nozzle; 5-second exposures).

Figure 17 shows how the distance maintained between the nozzle and hose influences damage. A rather dramatic increase in damage occurs when this distance is reduced, especially at elevated pressures. Also of interest is the extreme sensitivity to distance. A decrease of only 1 in. (25.4 mm) can make the difference between no damage and some visible damage, or between slight damage and potentially catastrophic damage. Unfortunately, there are no commercially available guards which prevent the nozzle from coming too close to a part, and which do not hinder cleaning operations in confined work spaces.

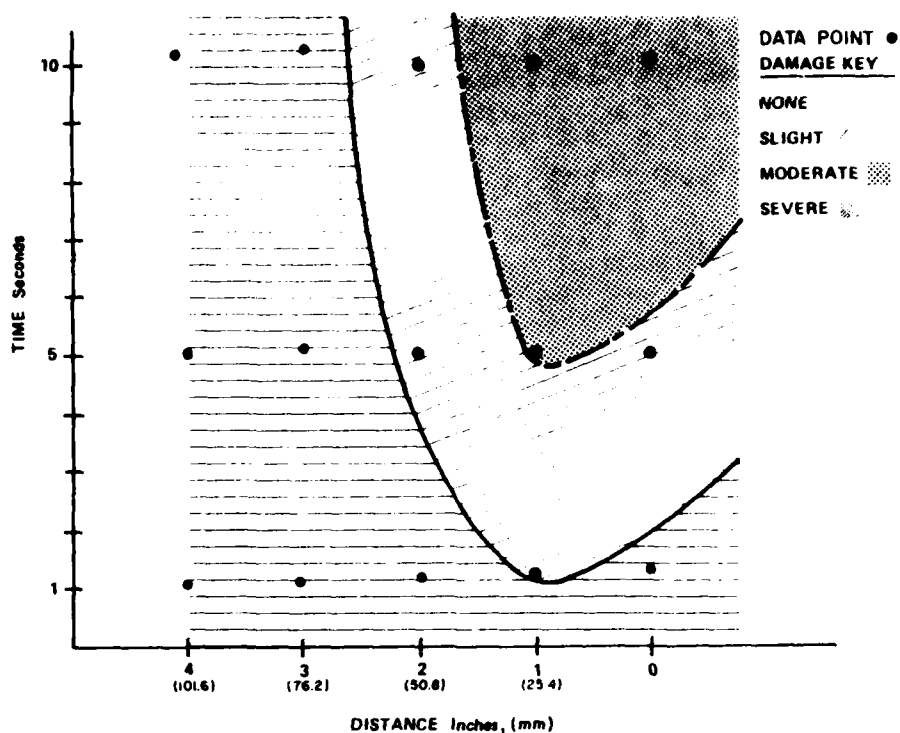
Figure 18. Damage to radiator hose as a function of time and distance at recommended settings of 800 psi (55.12 kPa), 130°F (54°C), 25-degree nozzle, 3.5 gpm (13.2 L/min).

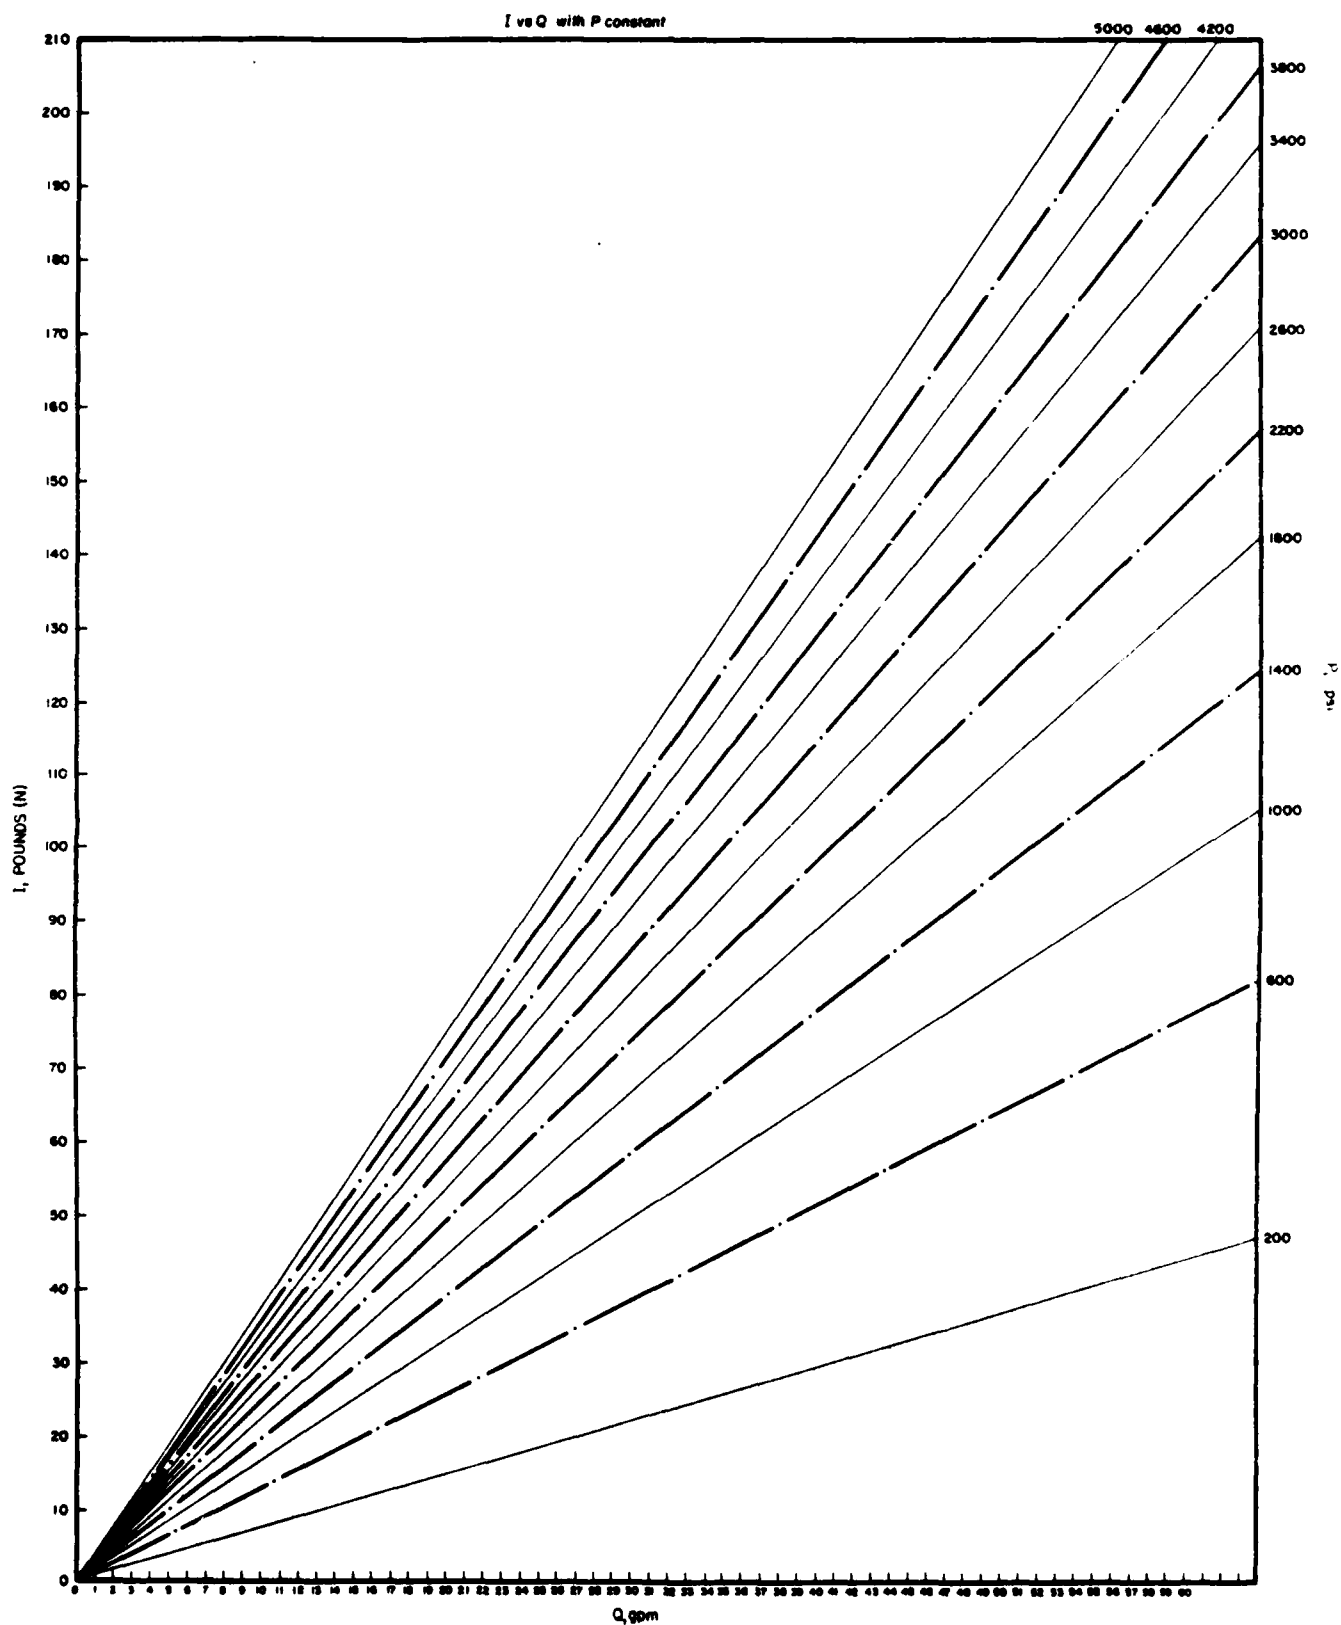
Figure A1. Theoretical total impact (metric conversion factors: 1 gpm = 6×10^{-5} m³/sec; 1 psi = 6.89 kPa; 1 pound force = 4.448 N).

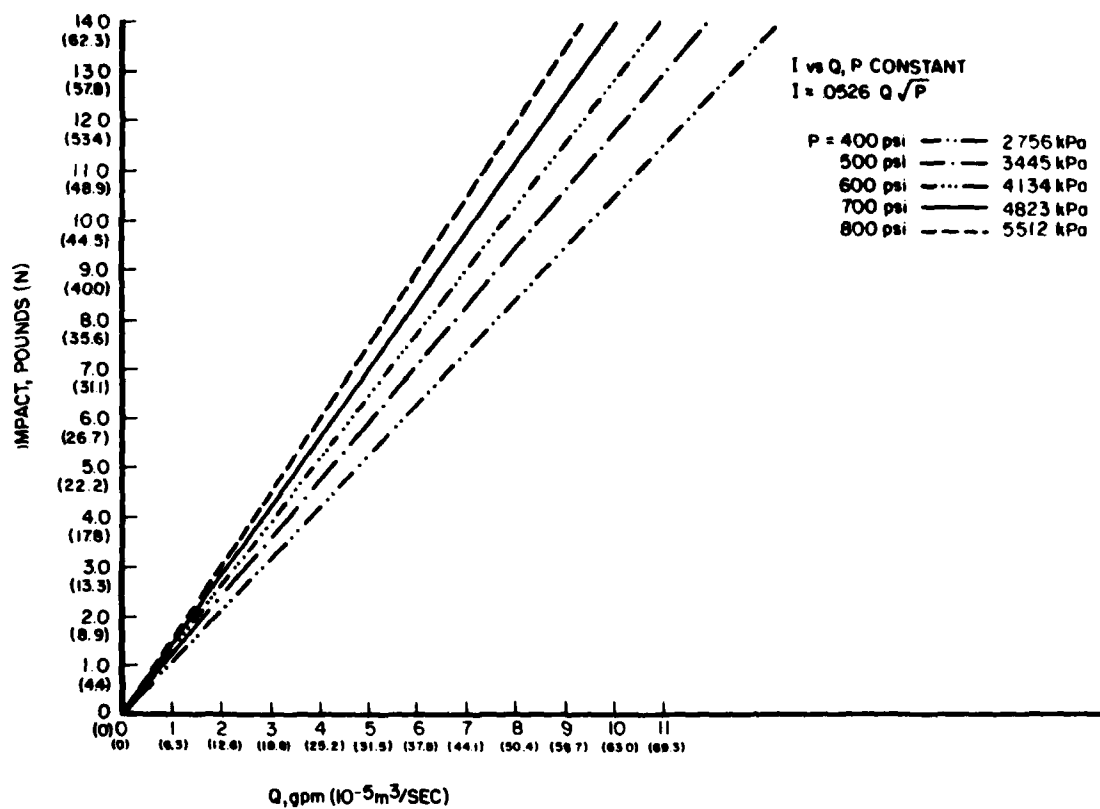
Figure A2. Theoretical total impact; increased scale.

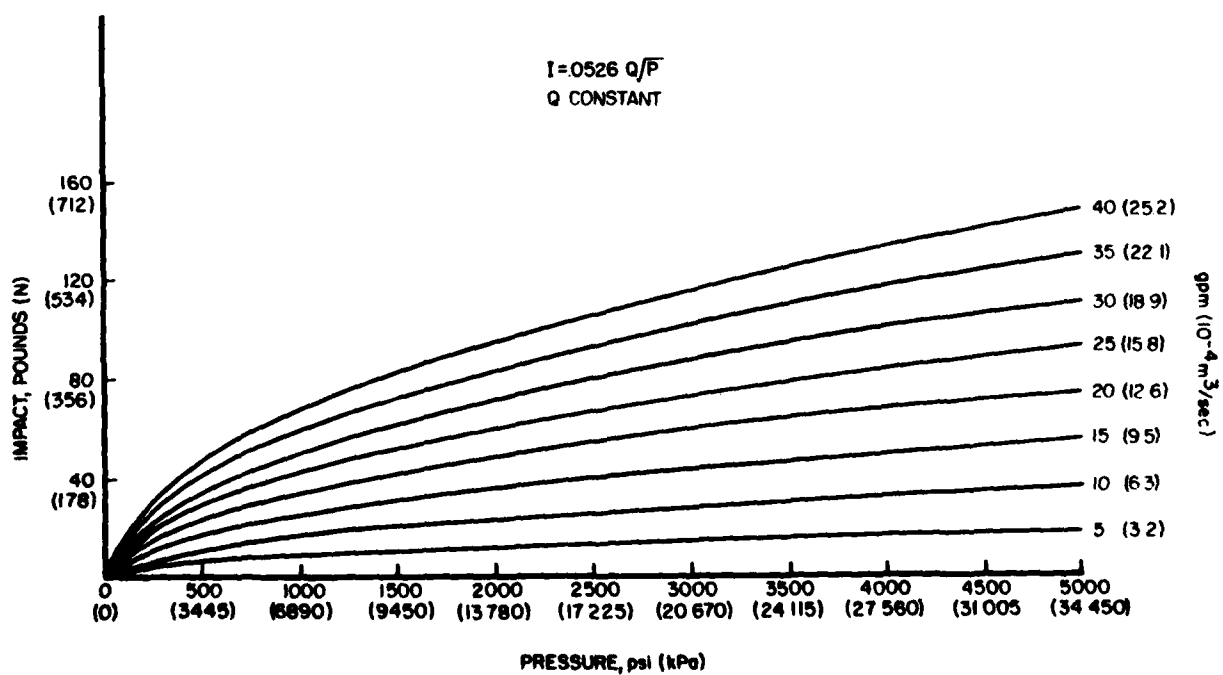
Figure A3. Impact versus pressure; Q constant.

$$I = .0526 Q \sqrt{P}$$

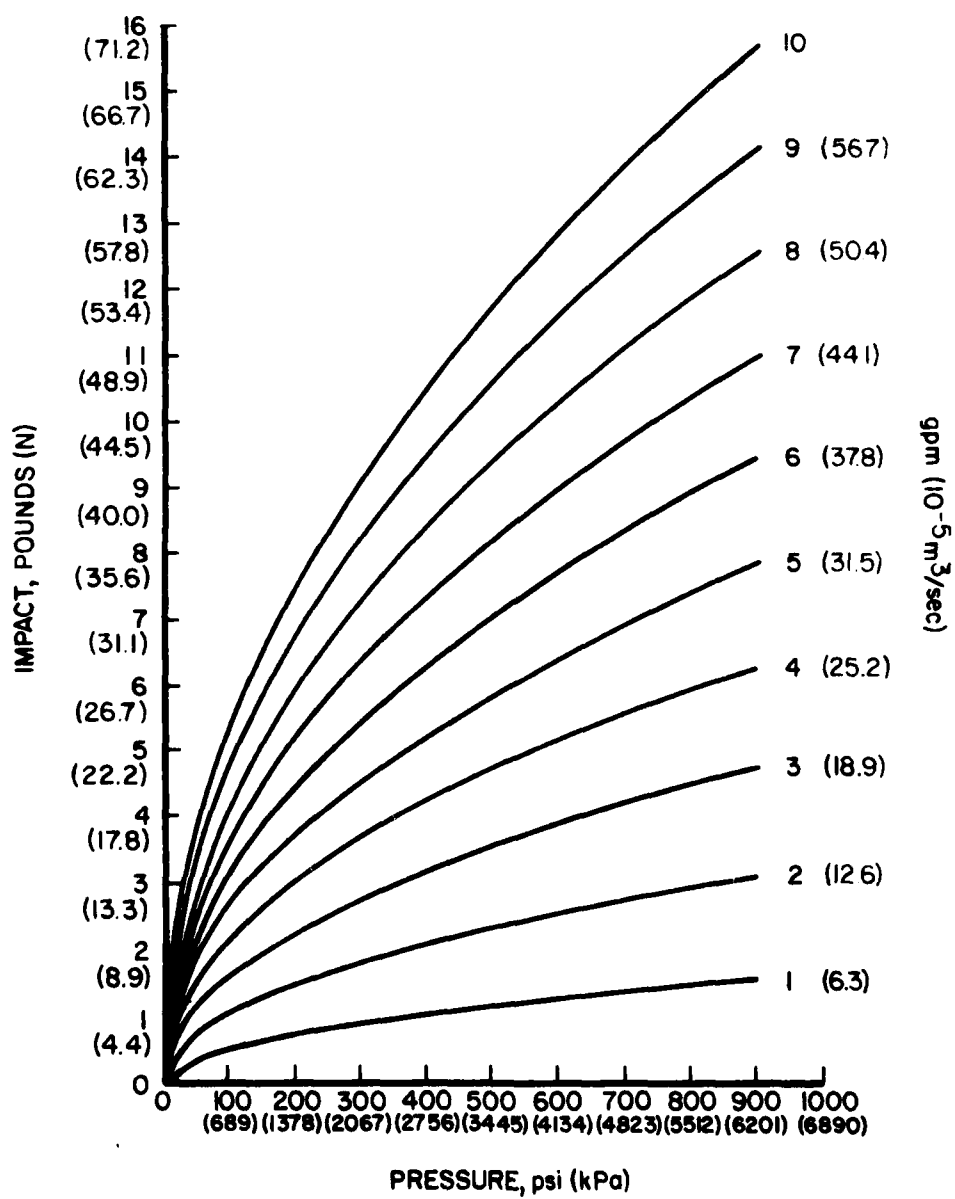
Figure A4. Impact versus pressure; expanded scale.

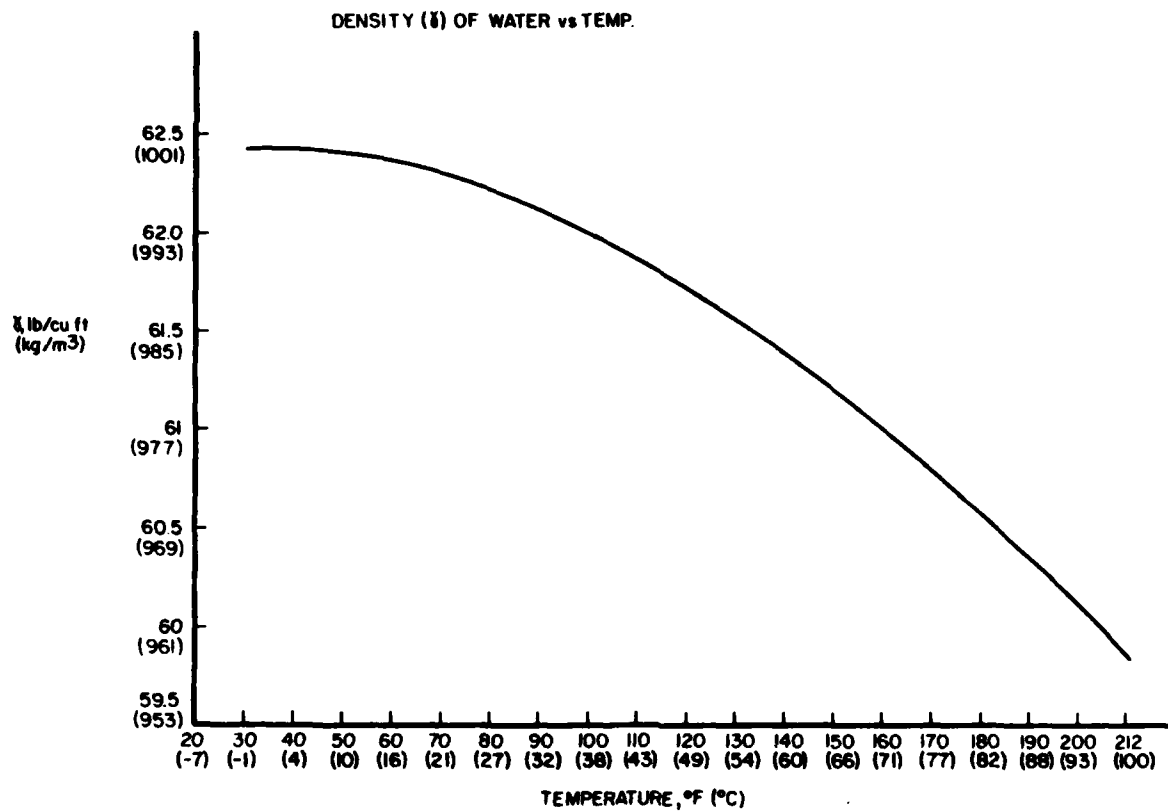
Figure A5. Density of water versus temperature.

EQ A2 IS BASED ON 70°F (21°C) WATER, $\bar{v} = 62.3 \text{ lb/cu ft (997.4 kg/m}^3\text{)}$

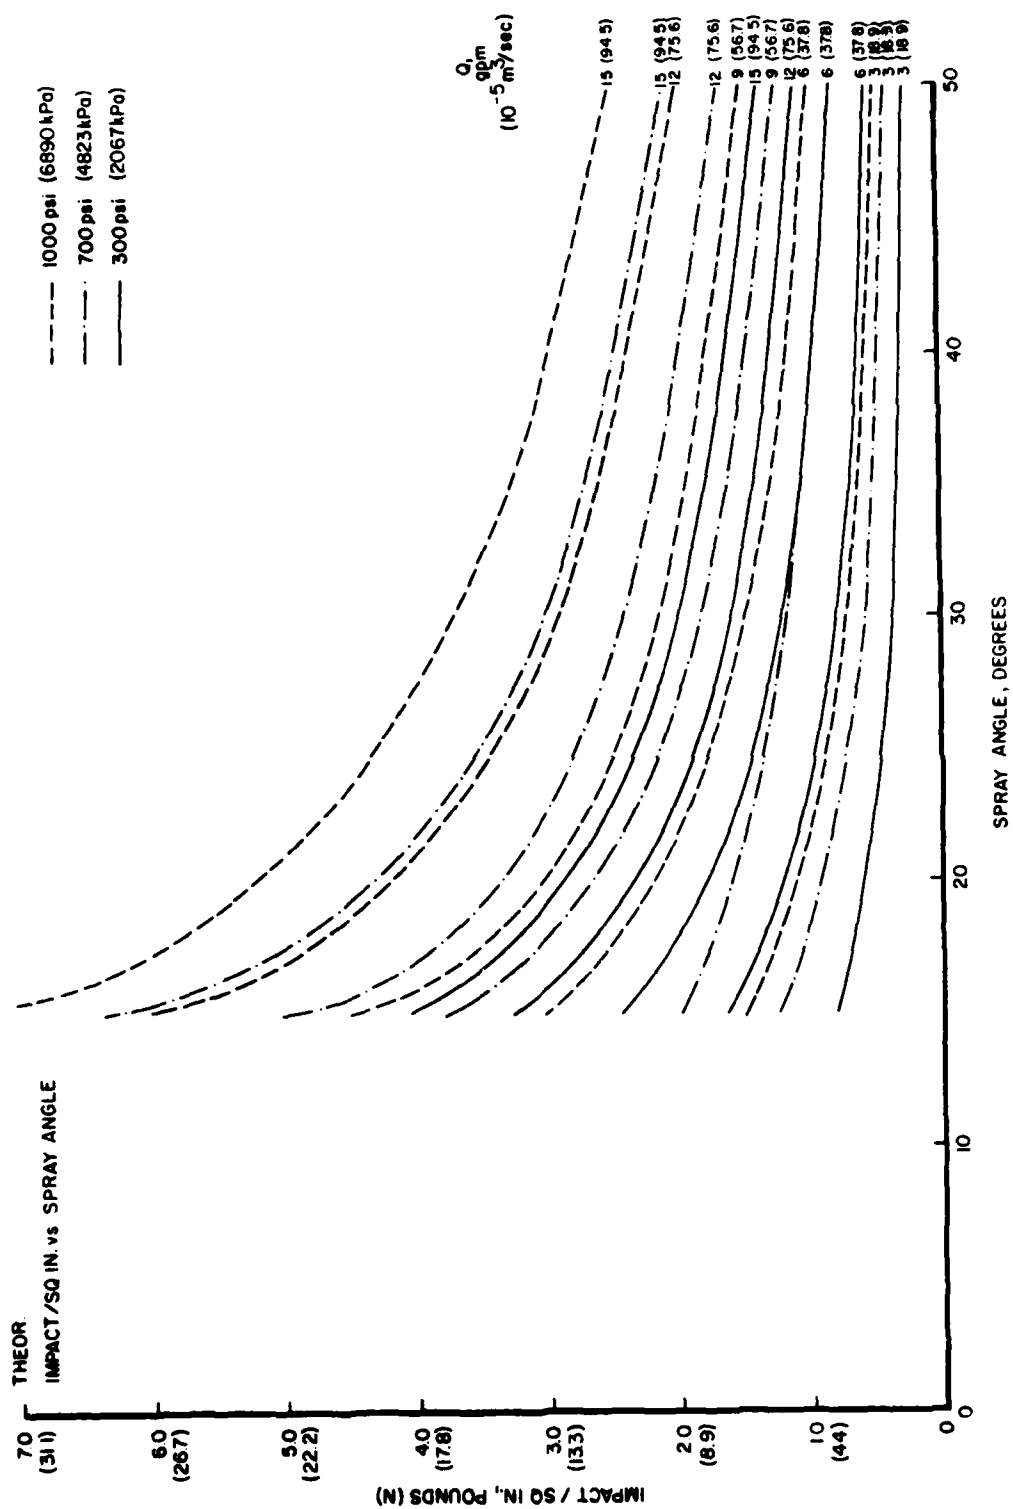
Figure A8. Theoretical impact with Flatjet spray.

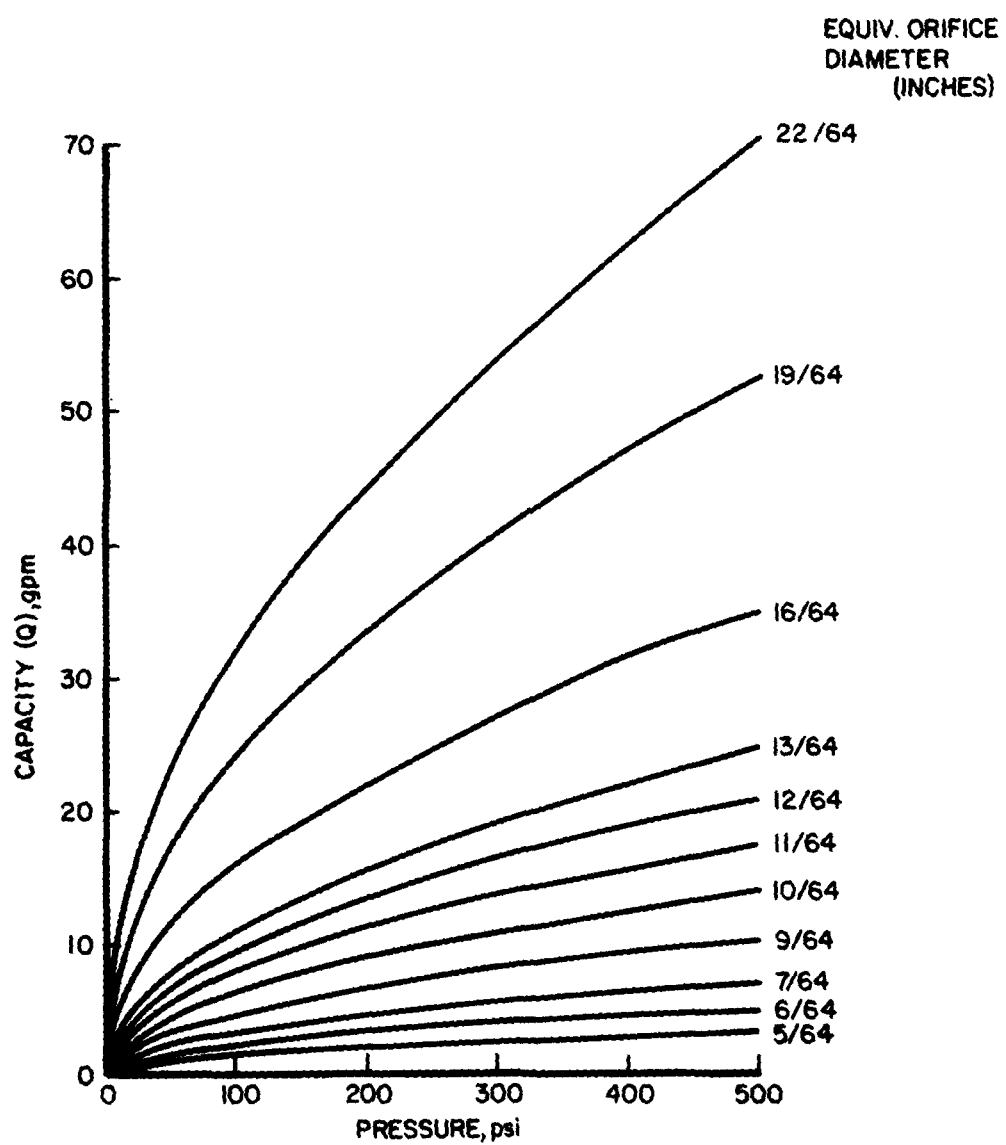
Figure A9. Flow rate for nozzle with 40-degree spray angle (metric conversion factors: 1 in. = 25.4 mm; 1 gpm = $6 \times 10^{-5} \text{ m}^3/\text{sec}$; 1 psi = 6.89 kPa).
